# COAL ASH IMPOUNDMENT SITE ASSESSMENT DRAFT REPORT

**F. B. Culley Power Generating Station  
Vectren Corporation  
Newburgh, Indiana**

KLEINFELDER PROJECT NUMBER 112618-1

**September 2010**

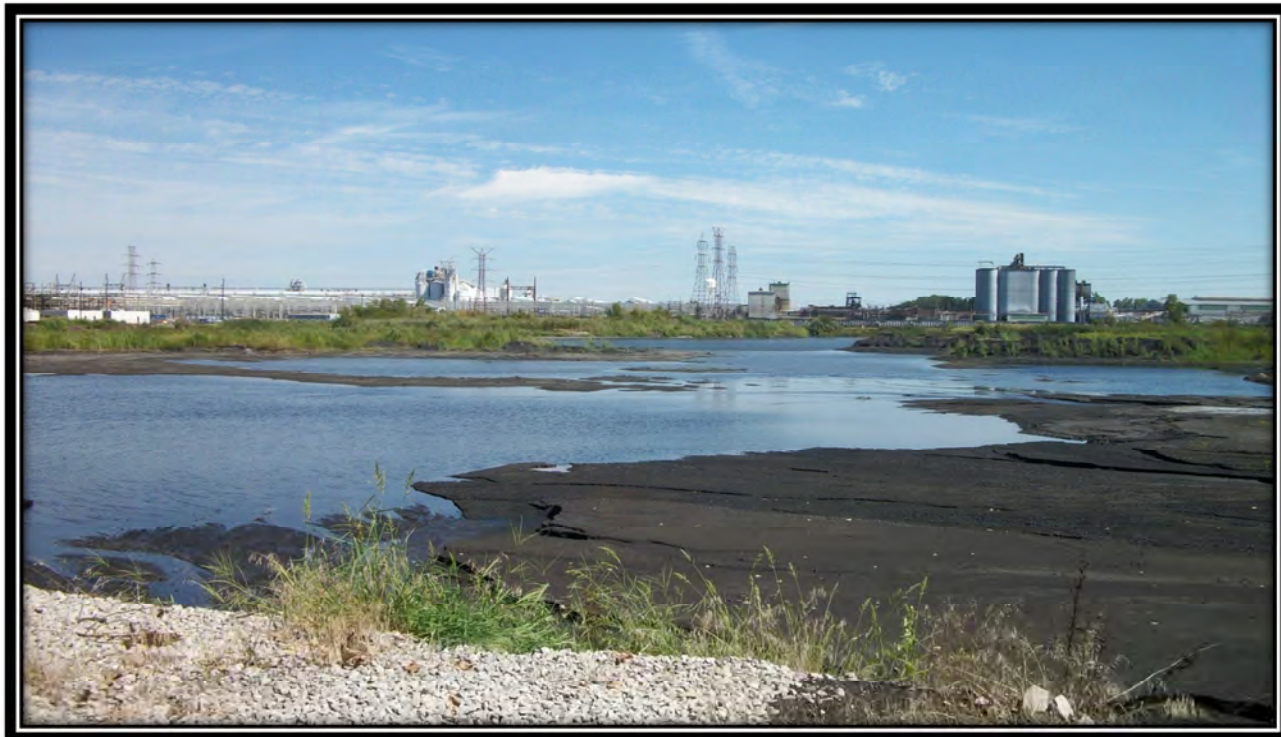
Photo 1 – West pond looking north from southeast corner

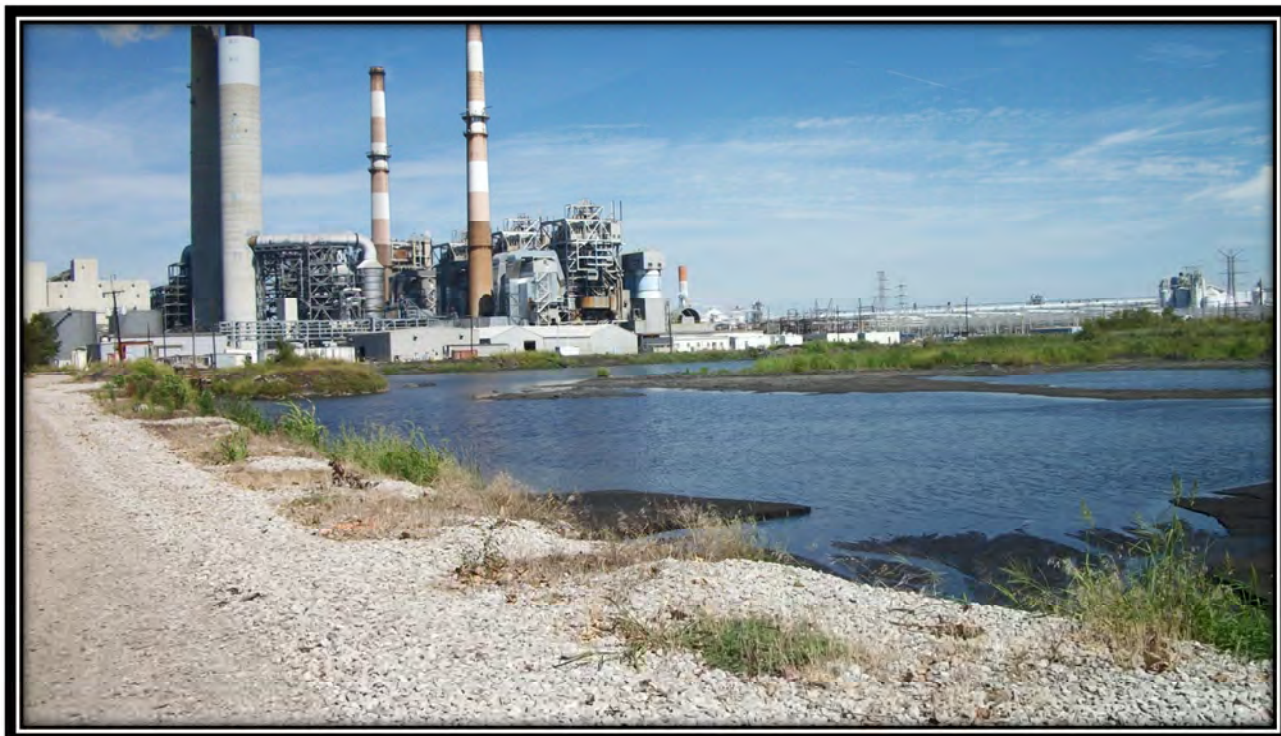
Photo 2 - West pond looking west along upstream south bank

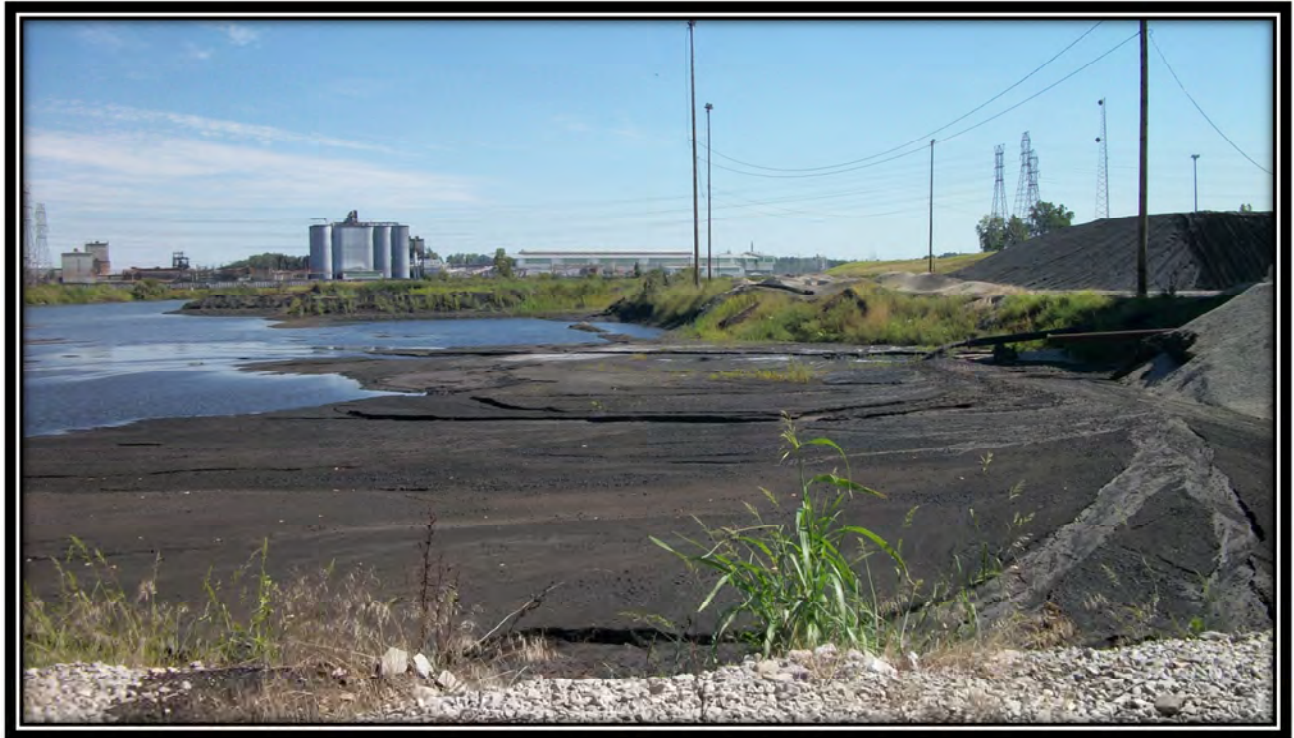
Photo 3 - West pond looking north along east bank

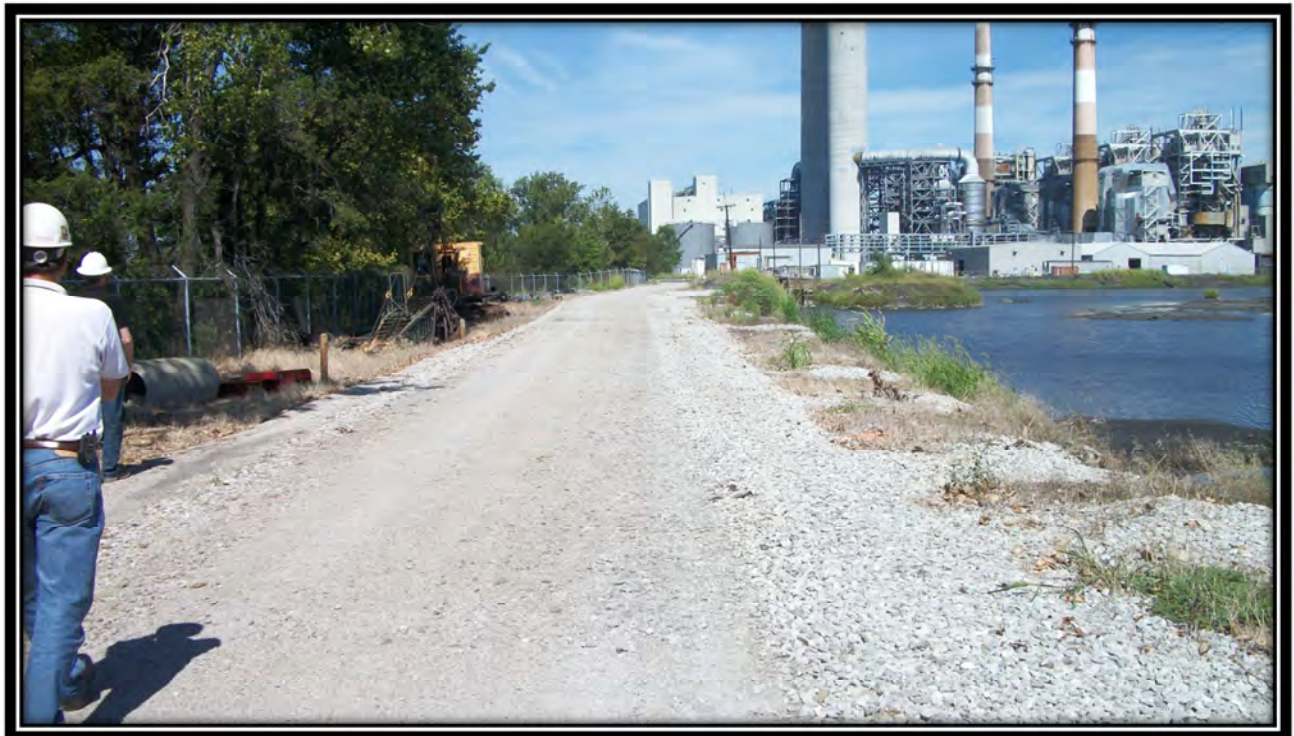
Photo 4 - West pond looking west along south bank

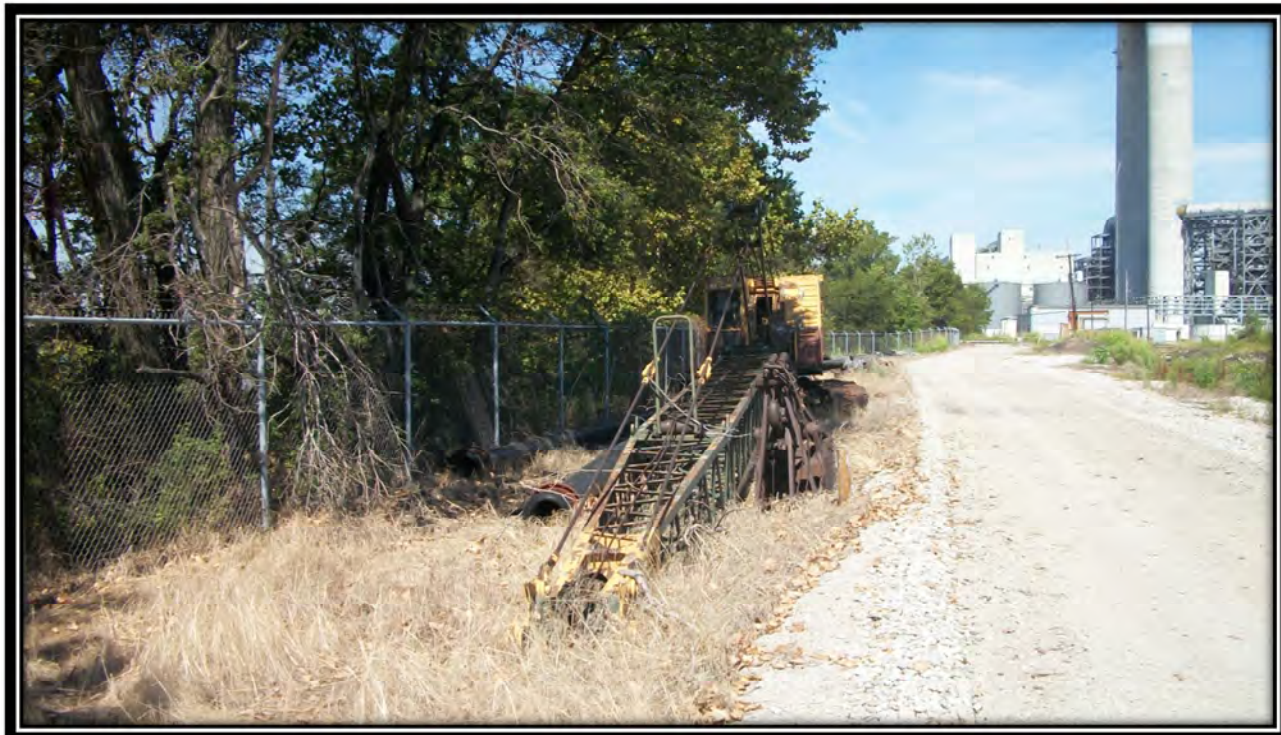
Photo 5 - West pond looking west along south bank

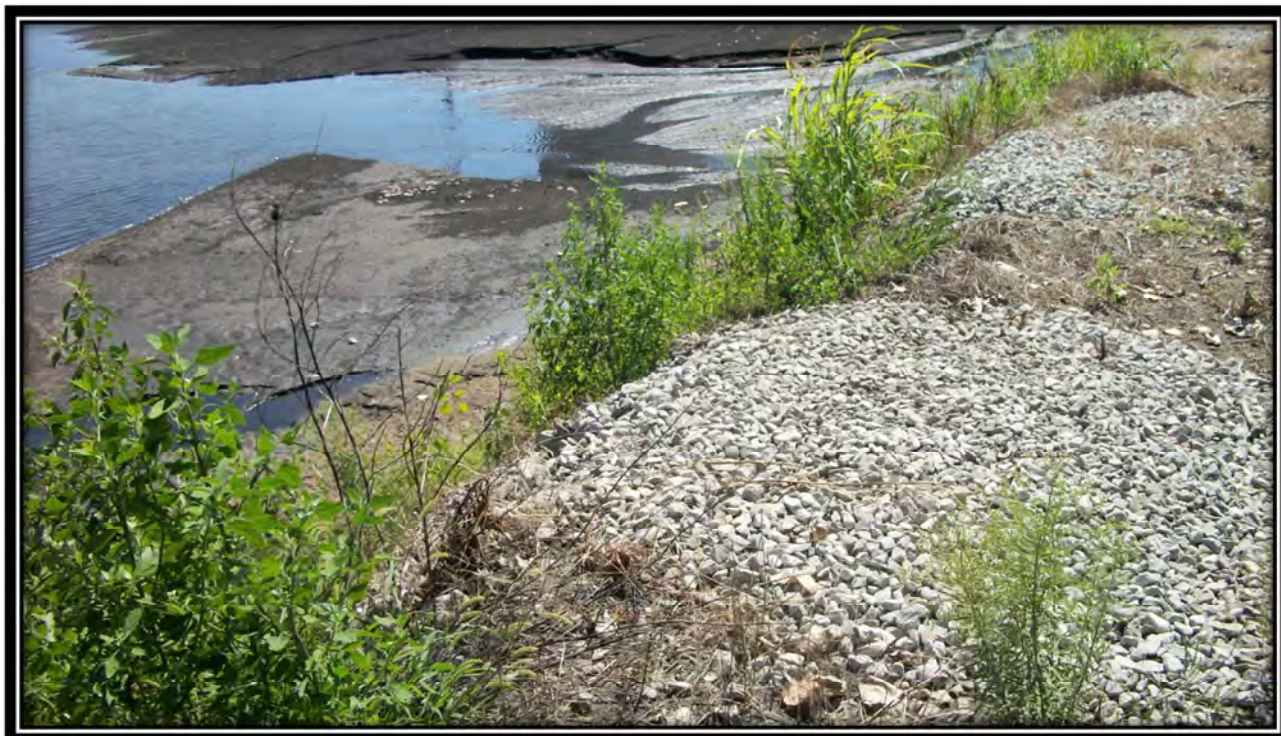
Photo 6 – Road gravel on upstream south bank near southwest corner

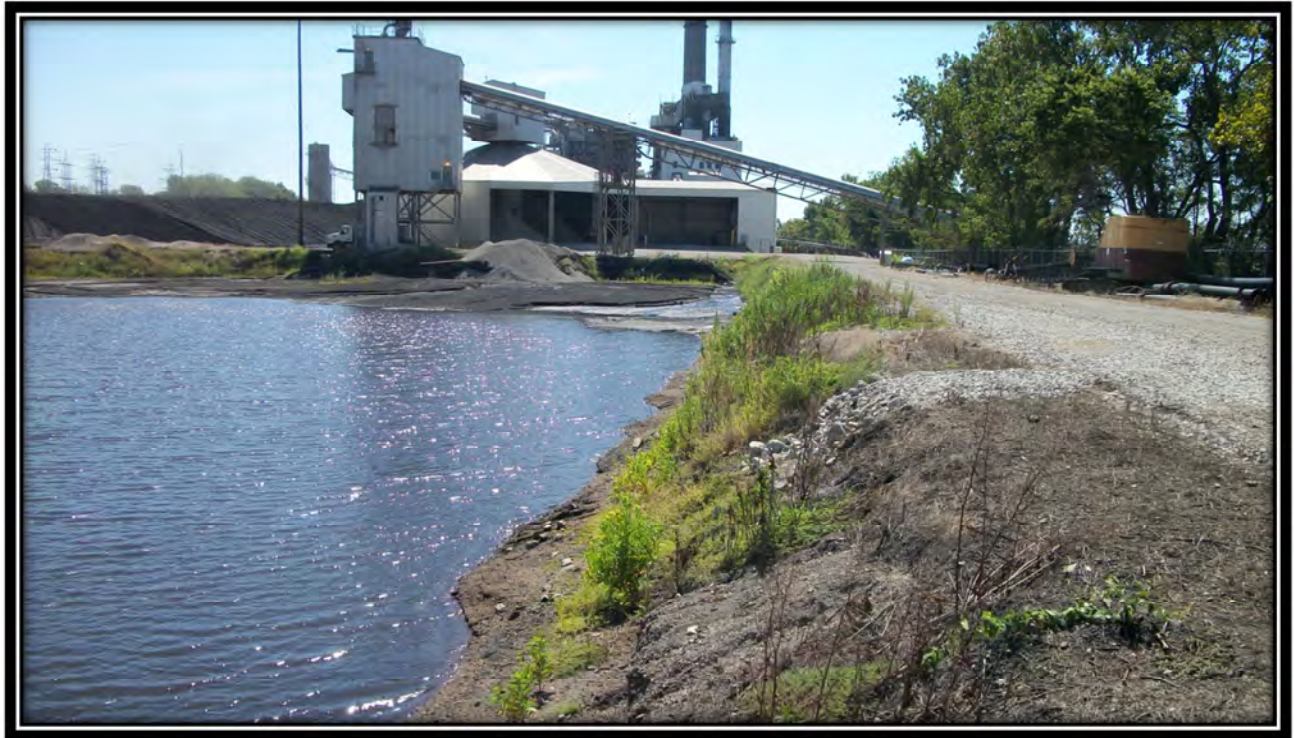
Photo 7 – West pond upstream south bank looking east at plant

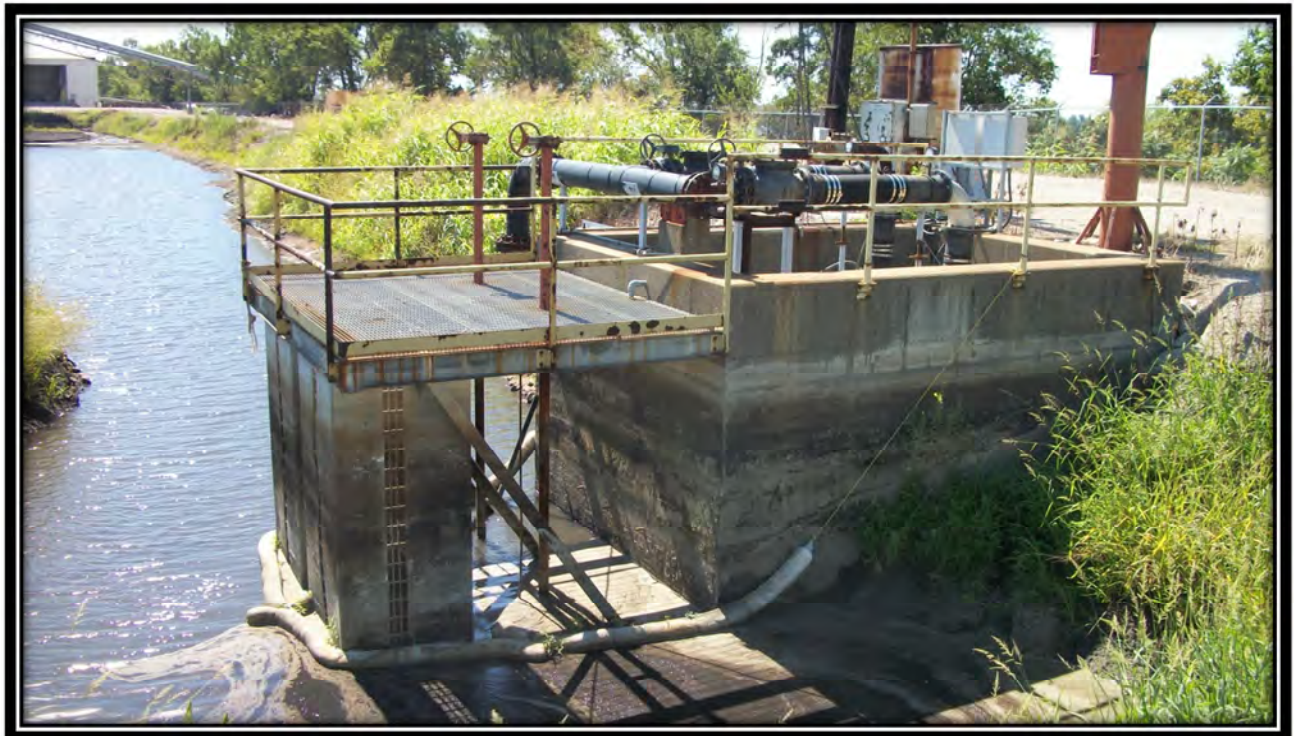
Photo 8 – West pond pump near southwest corner

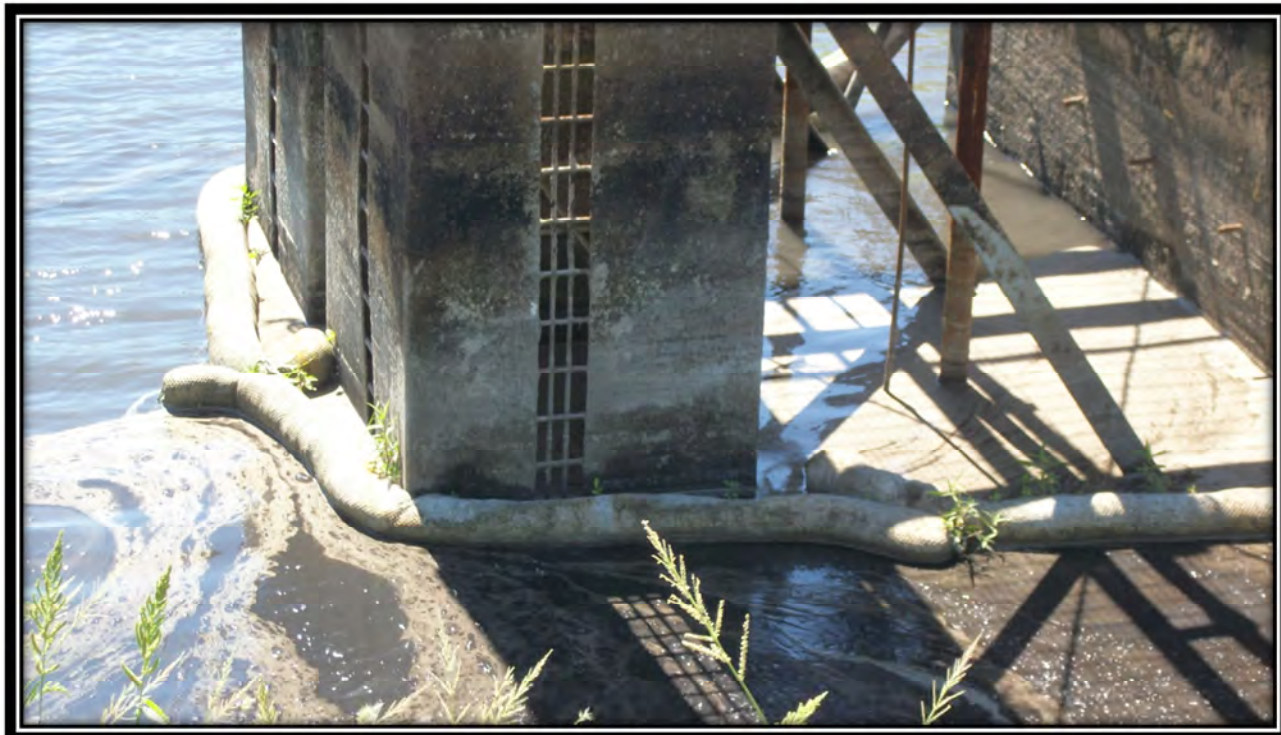
Photo 9 – West pond pump near southwest corner

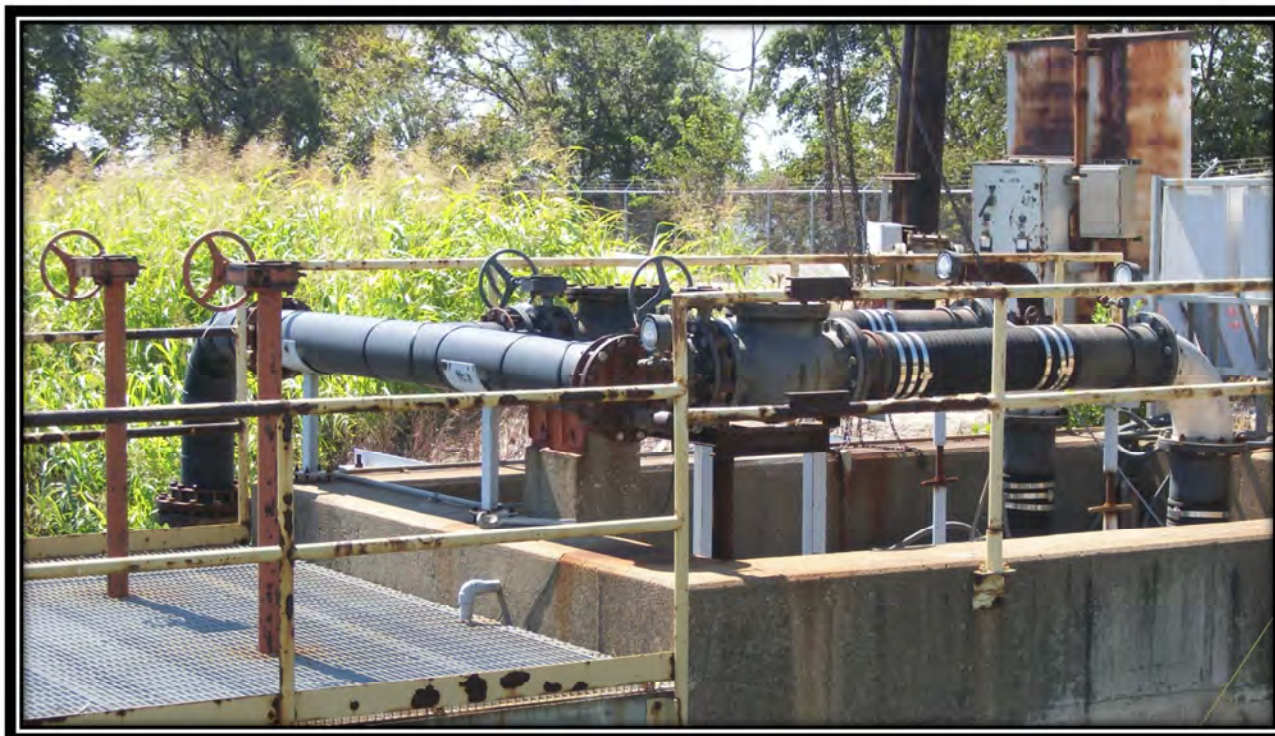
Photo 10 – West pond pump

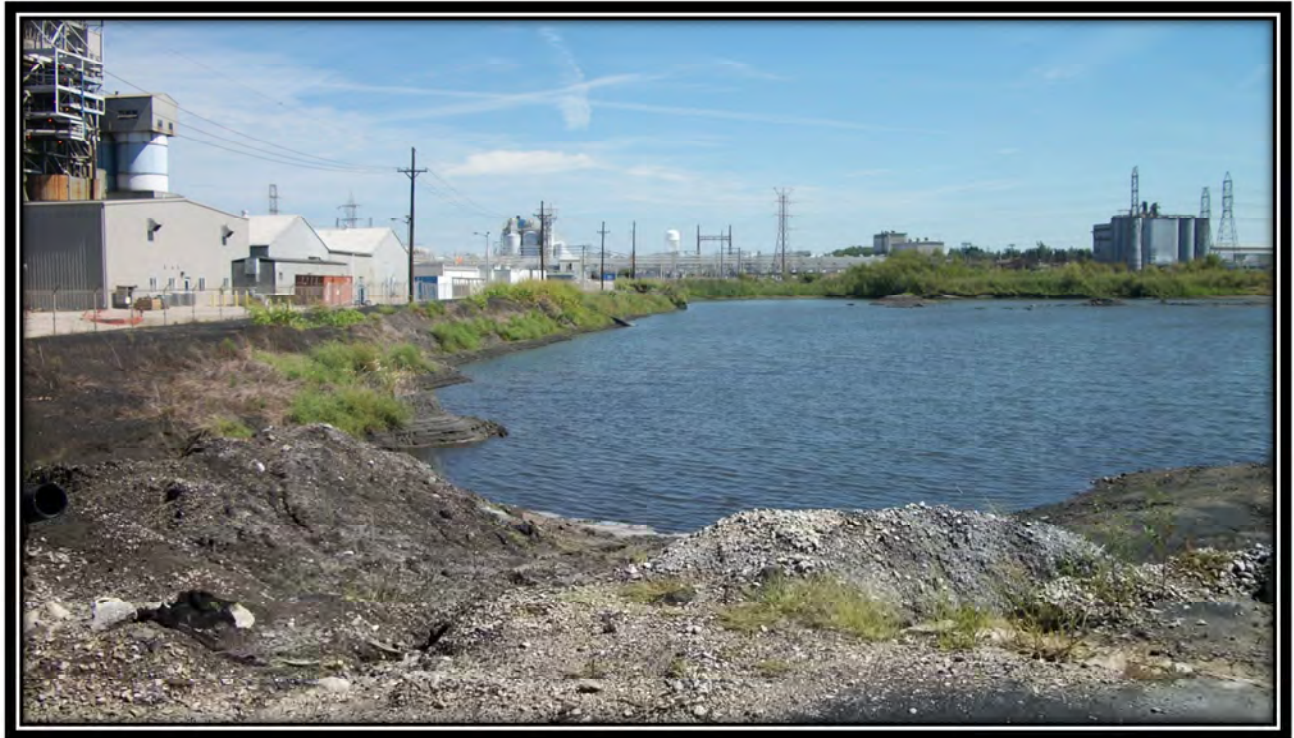
Photo 11 – West pond looking north along upstream west bank

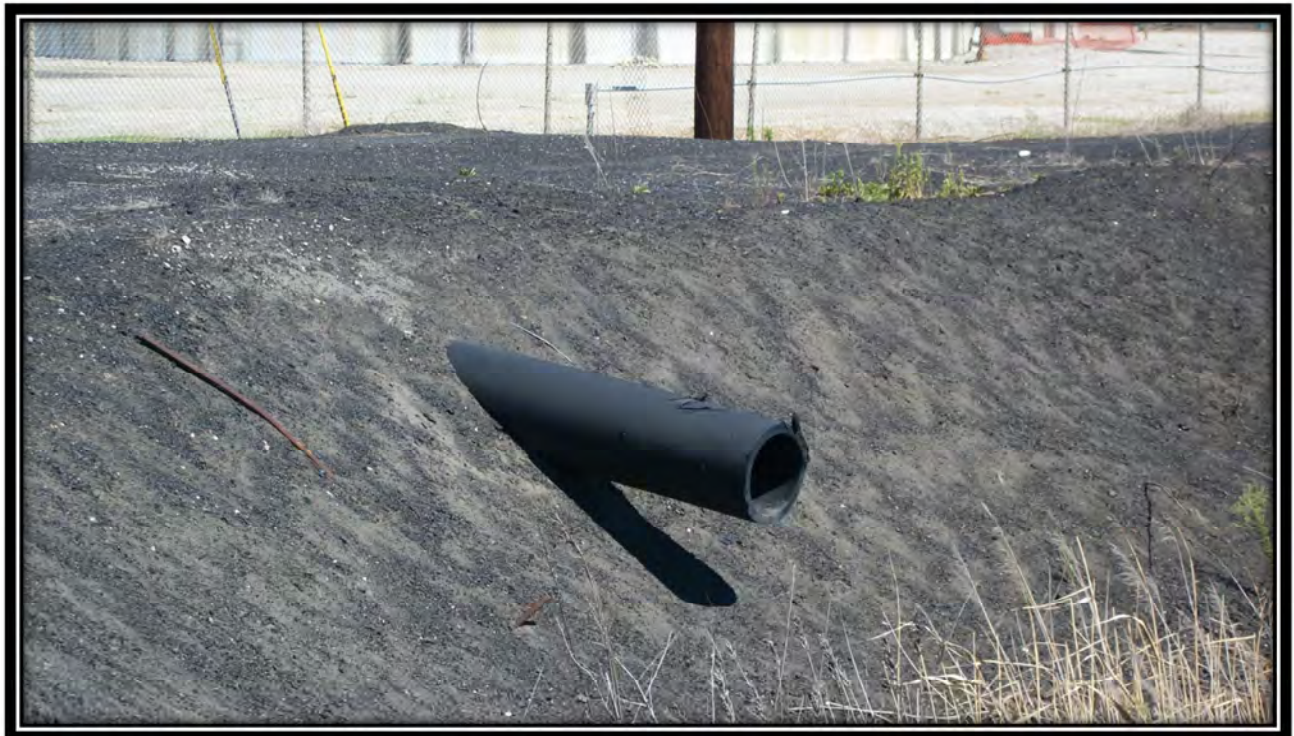
Photo 12 – Old ash line from neighboring site through west bank

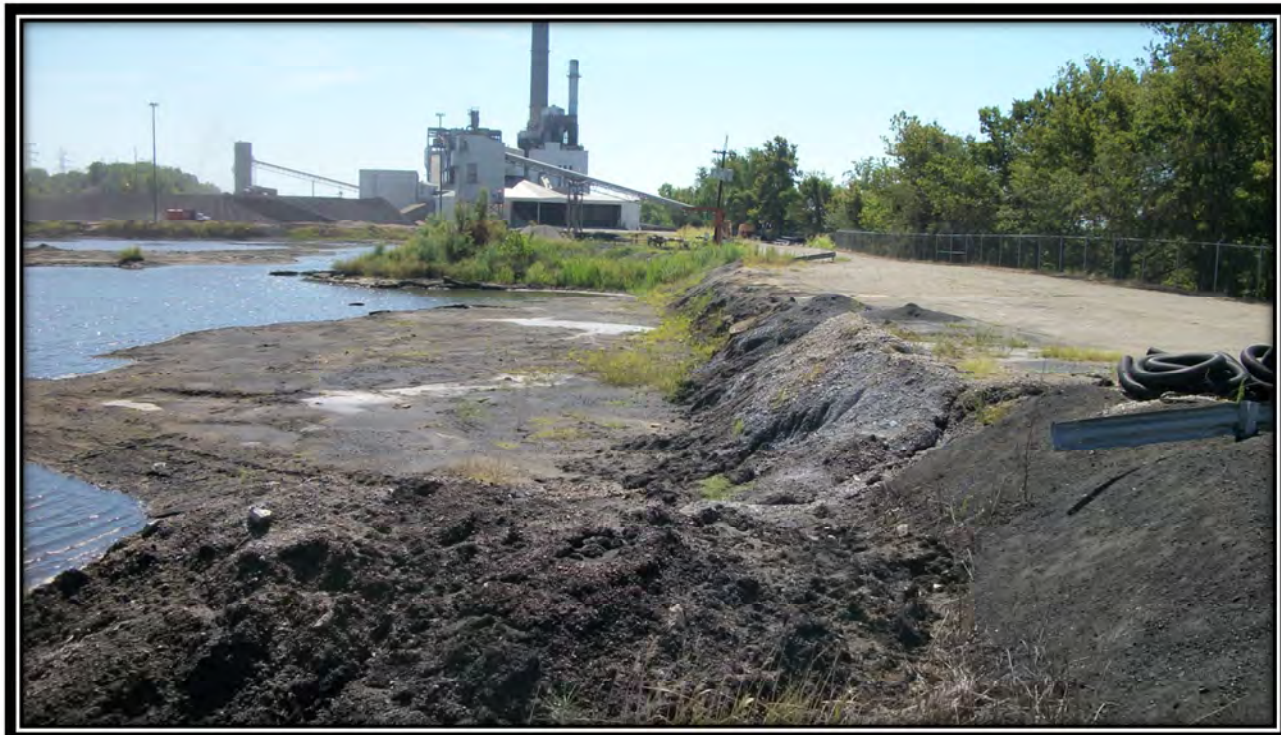
Photo 13 – West pond looking east along upstream south bank

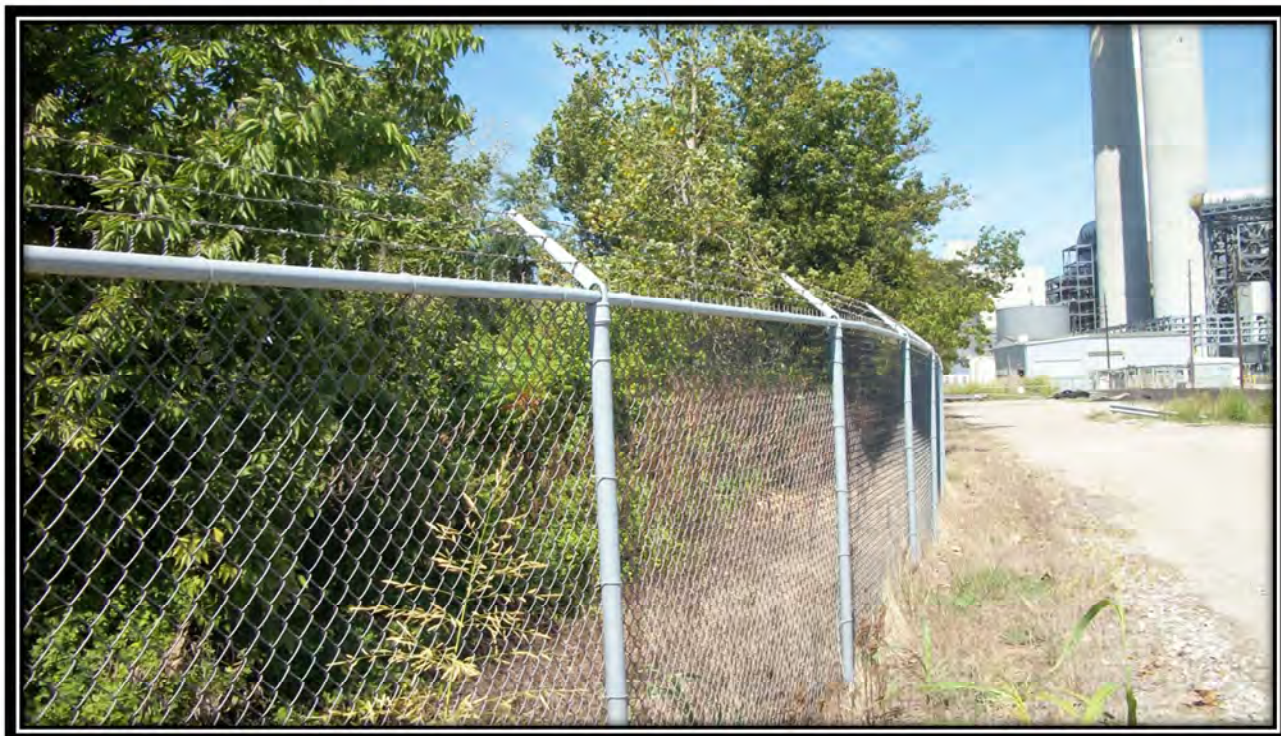
Photo 14 – West pond looking west along downstream top of south bank

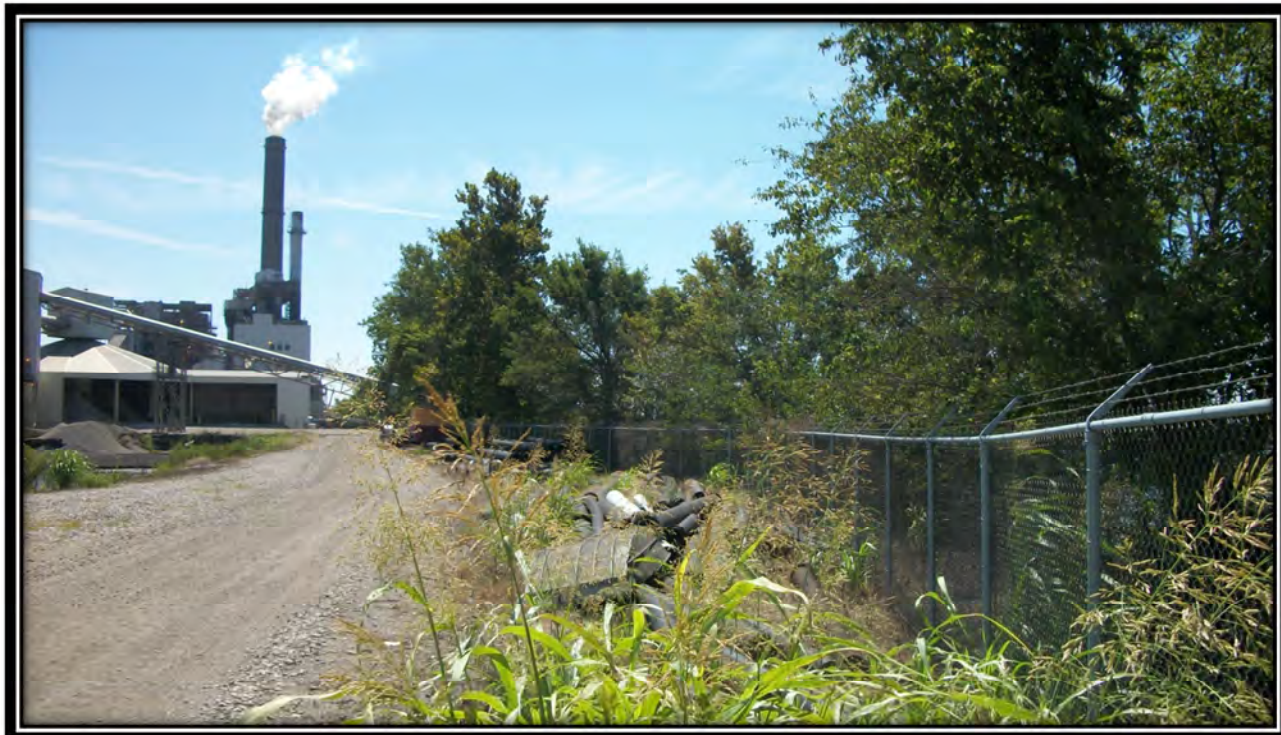
Photo 15 – West pond looking east along downstream top of south bank

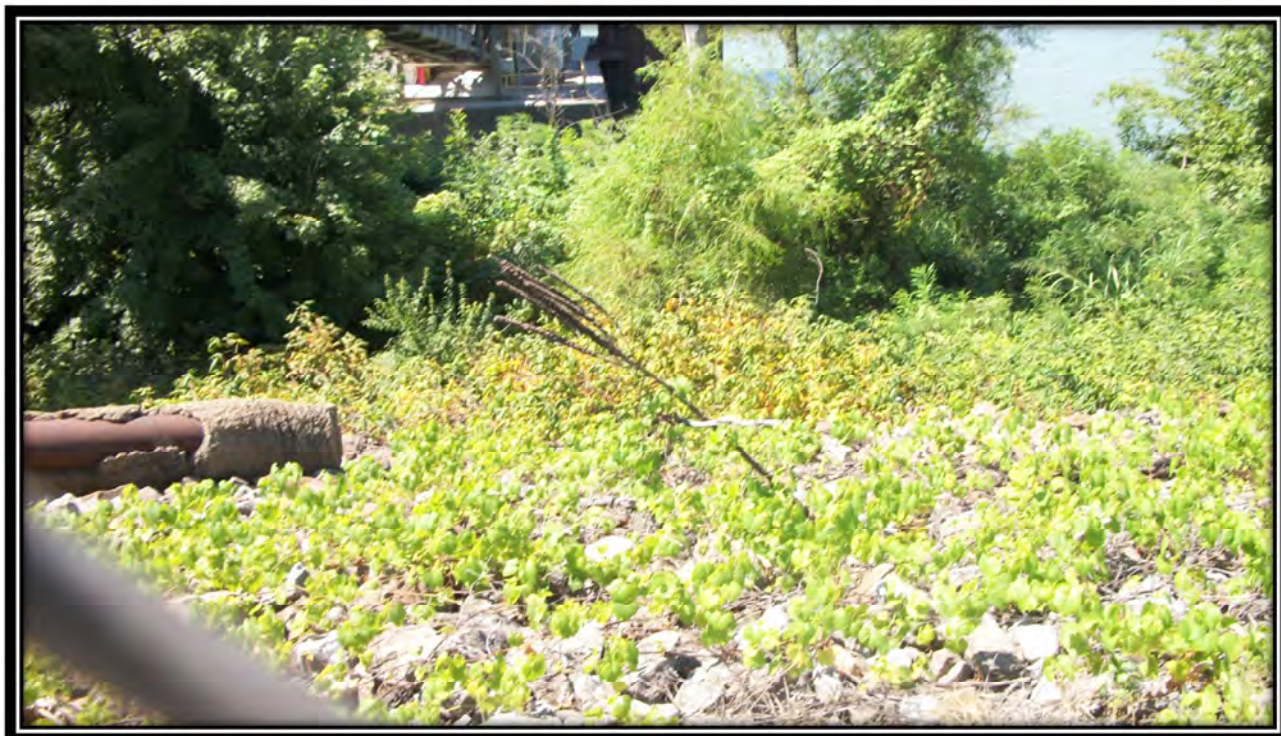
Photo 16 – Riprap and debris on downstream south slope of west pond near southeast corner

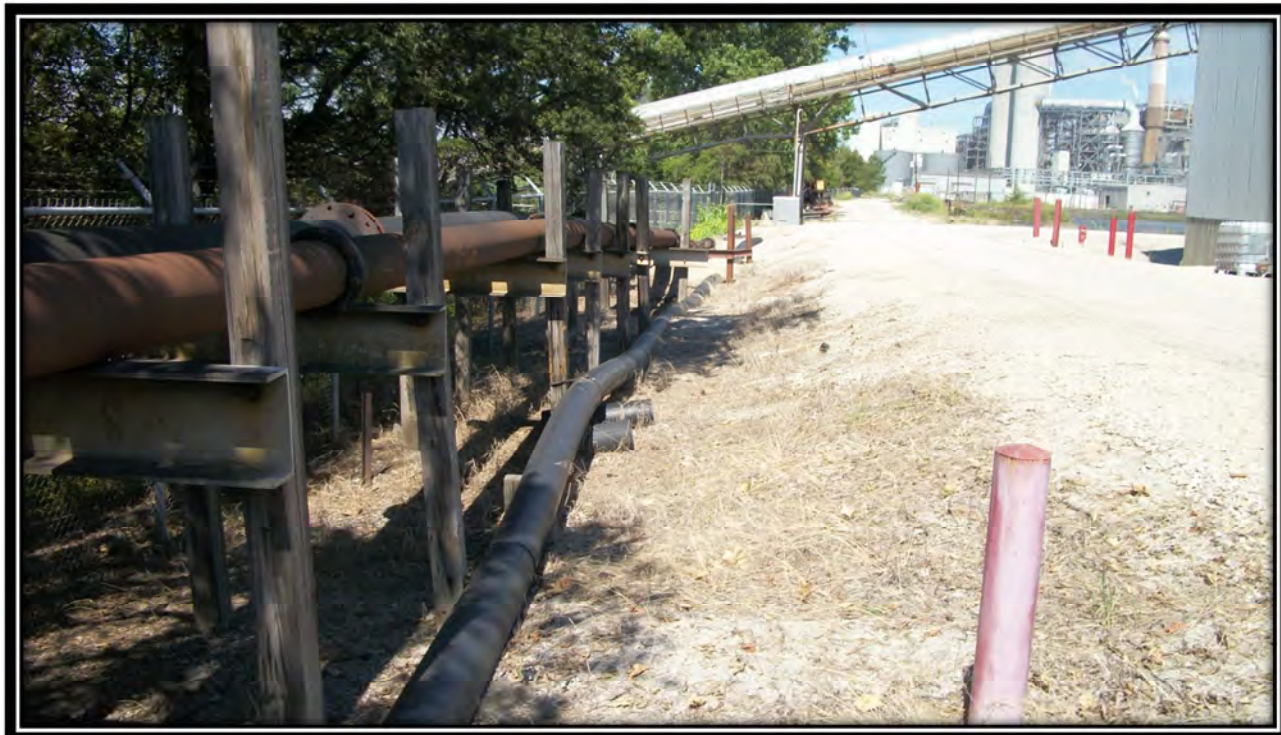
Photo 17 – Pump lines along plant between west and east ponds (looking west)

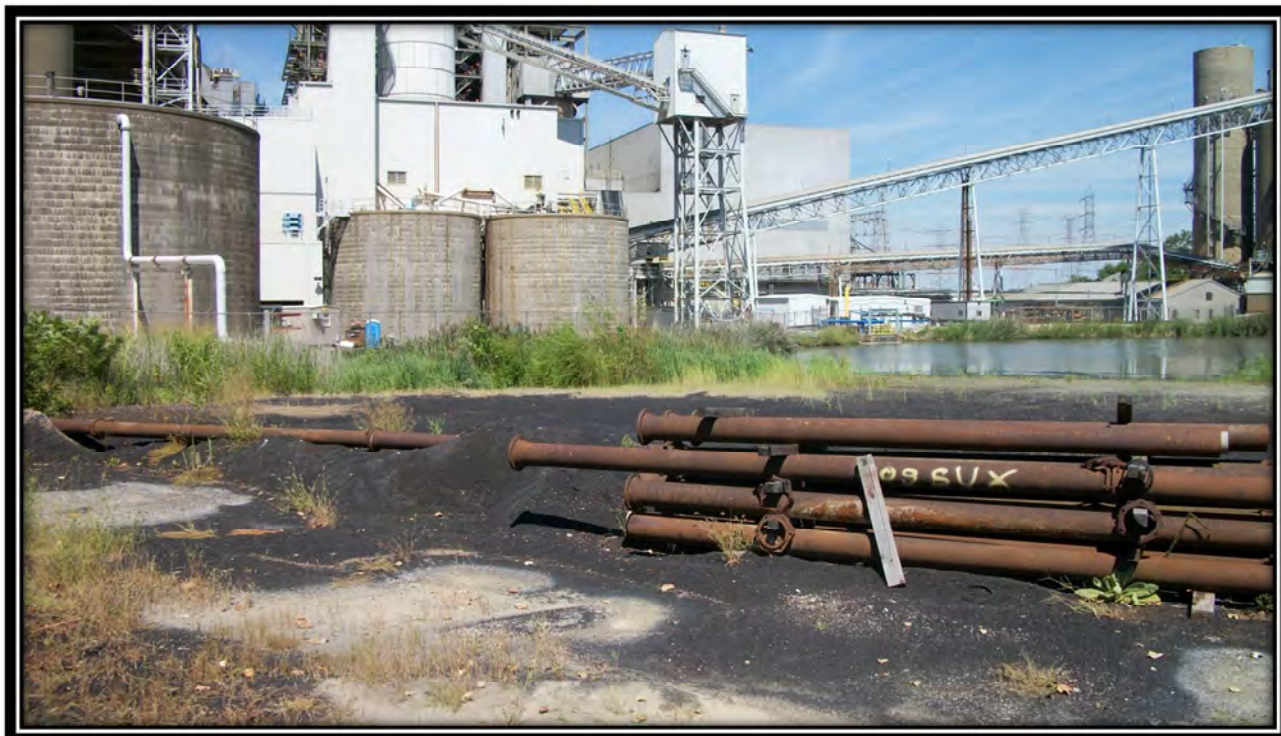
Photo 18 – East pond looking northwest from southwest corner

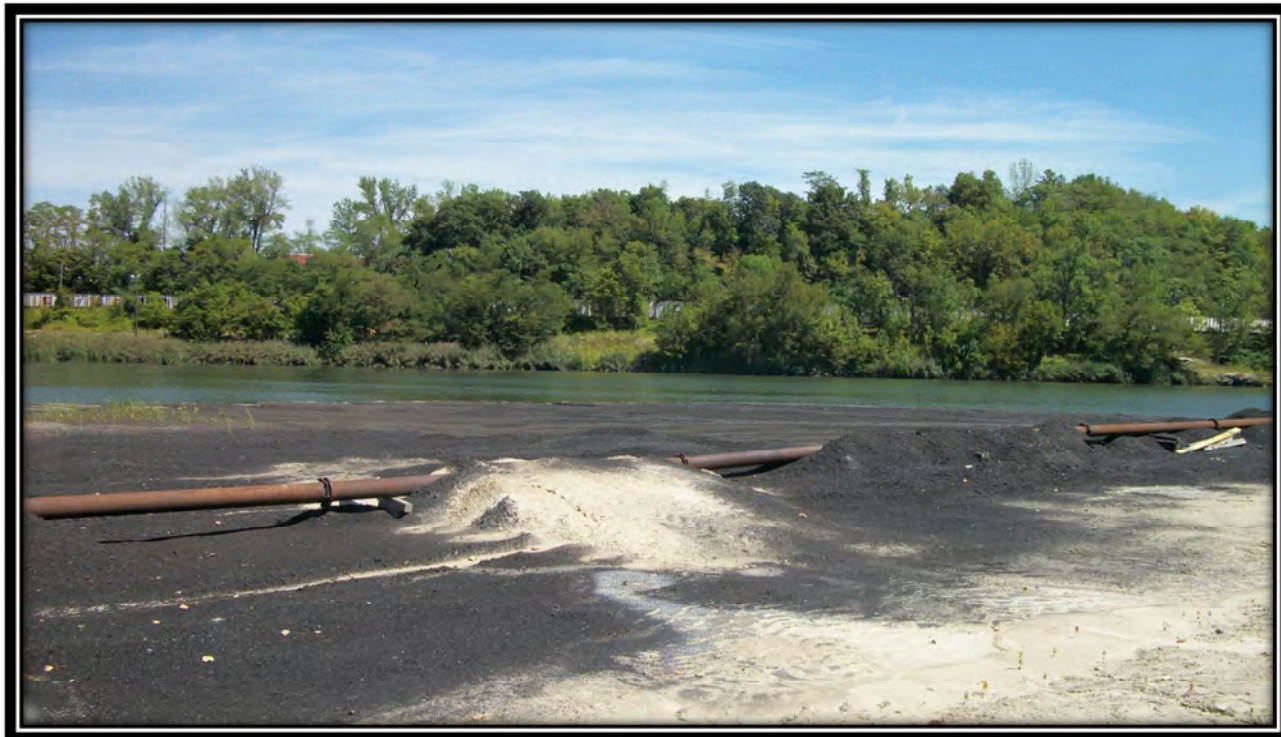
Photo 19 – East pond looking north from south bank

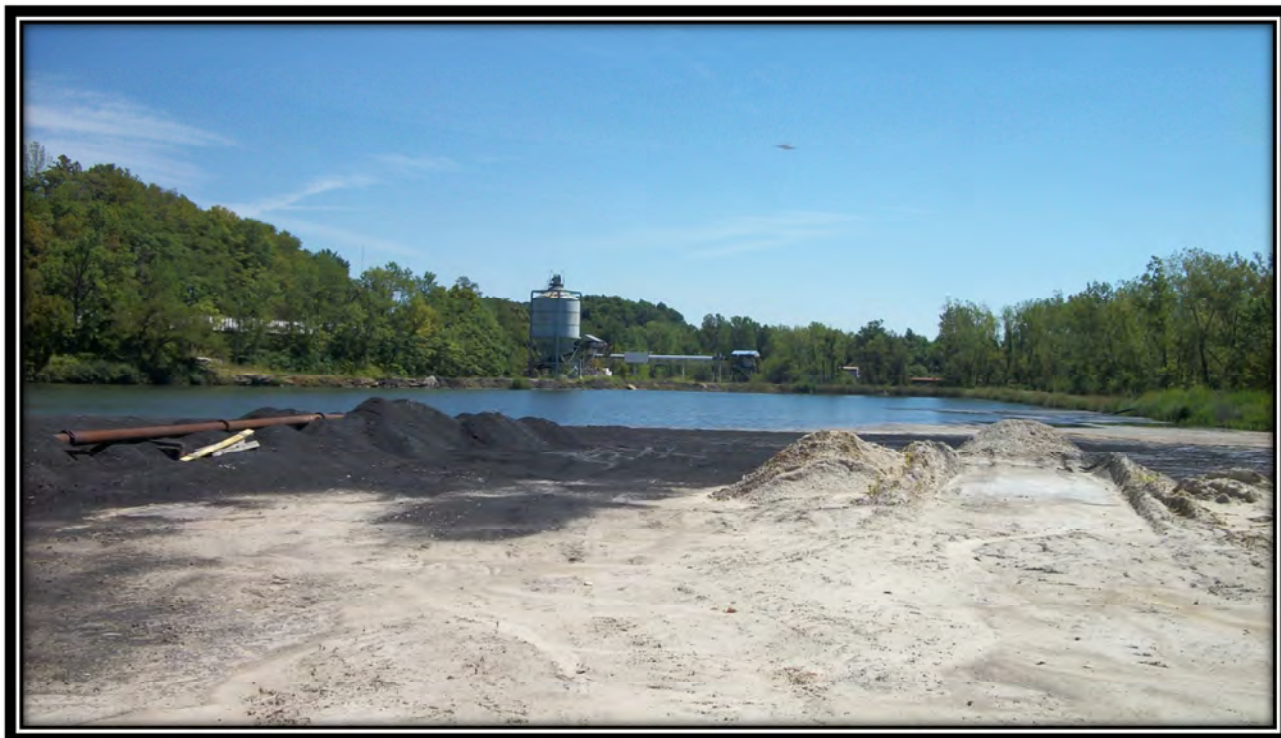
Photo 20 – East pond looking east from southwest corner

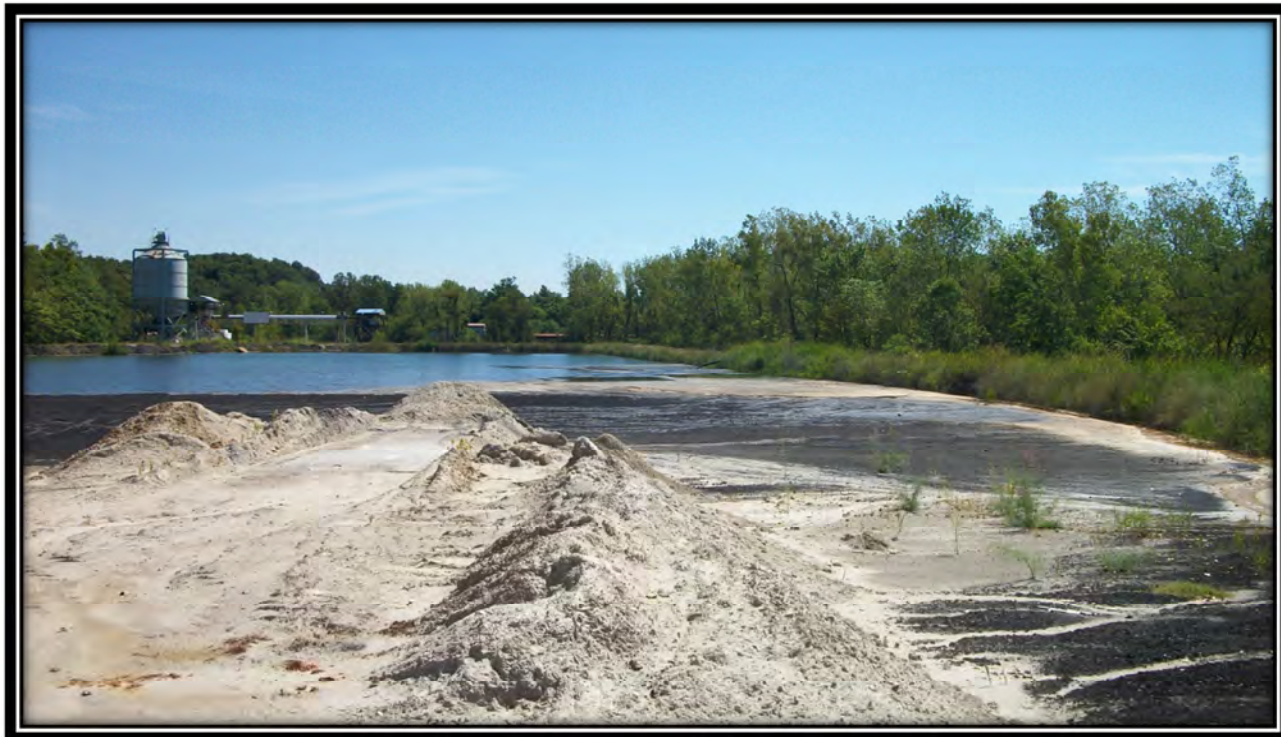
Photo 21 – East pond looking east

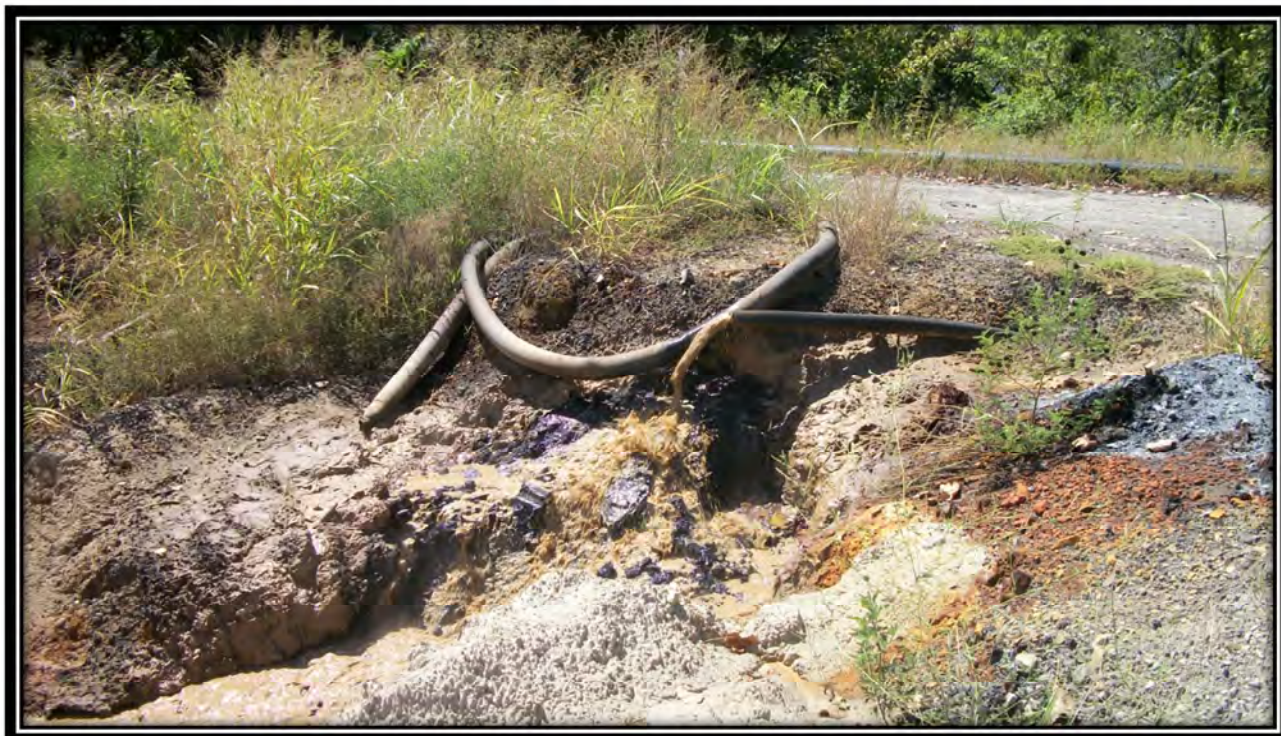
Photo 22 – Discharge pipe into east pond near southwest corner

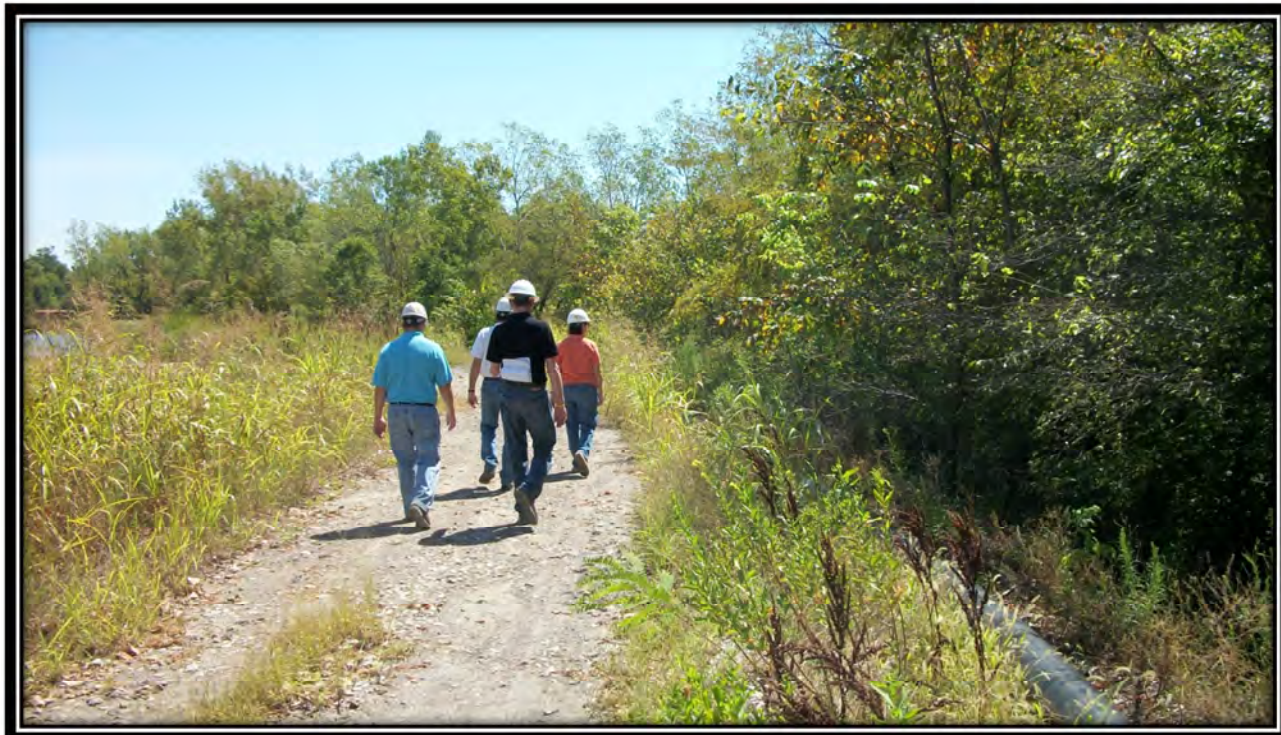
Photo 23 – East pond looking east along south bank

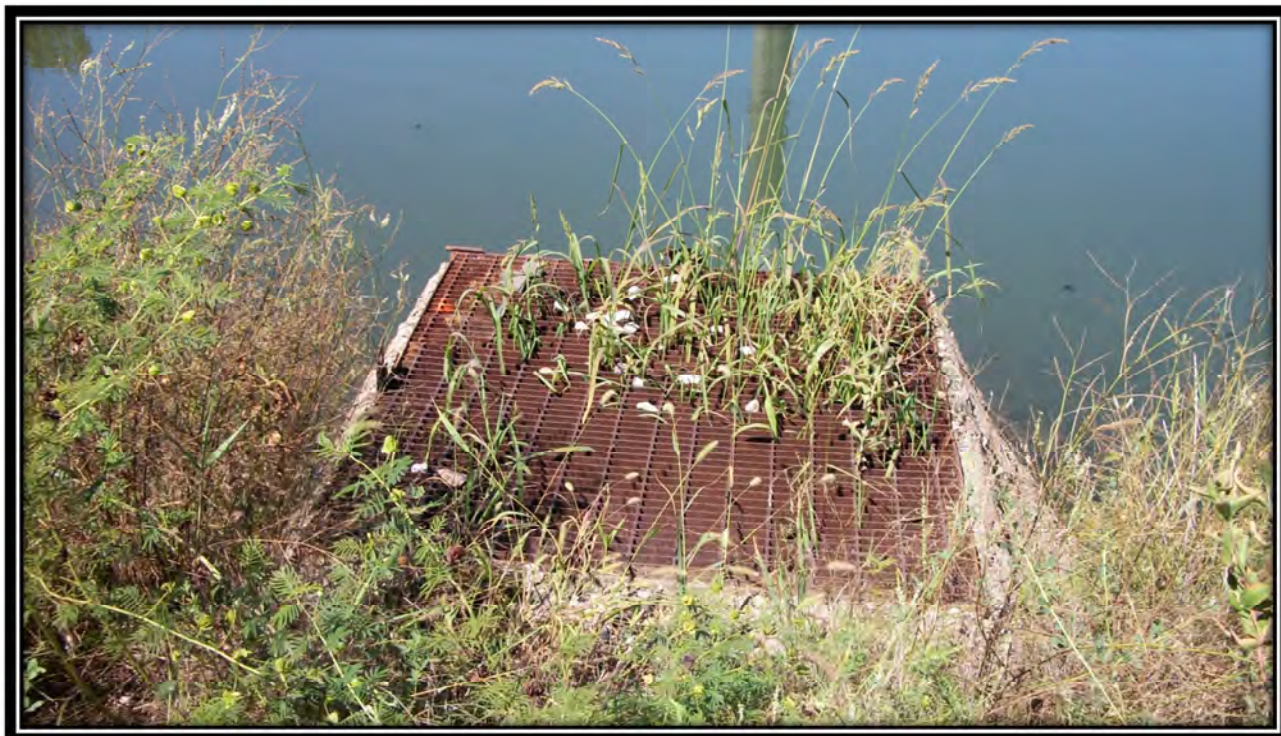
Photo 24 – Old overflow capped and plugged with concrete on east upstream bank
